LAKE CLASSIFICATION SHORT REPORT ON THE CAMELOT LAKES, ADAMS COUNTY, WI

**Presented by Reesa Evans, Lake Specialist
Adams County Land & Water Conservation Department
P.O. Box 287, Friendship, WI 53934**

AUGUST 2007

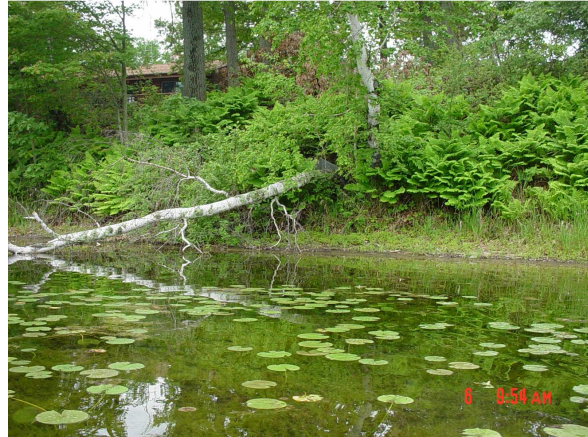
Example of Adequate Buffer

Shoreland buffers are an important part of lake protection and restoration. These buffers are simply a wide border of native plants, grasses, shrubs and trees that filter and trap soil & similar sediments, fertilizer, grass clippings, stormwater runoff and other potential pollutants, keeping them out of the lake. A 1990 study by the Wisconsin Department of Natural Resources of Wisconsin shorelines revealed that a buffer of native vegetation traps 5 to 18 times more volume of potential pollutants than does a developed, traditional lawn or hard-armored shore. The filtering process and bank stabilization that buffers provide help improve a lake's water quality, including water clarity.

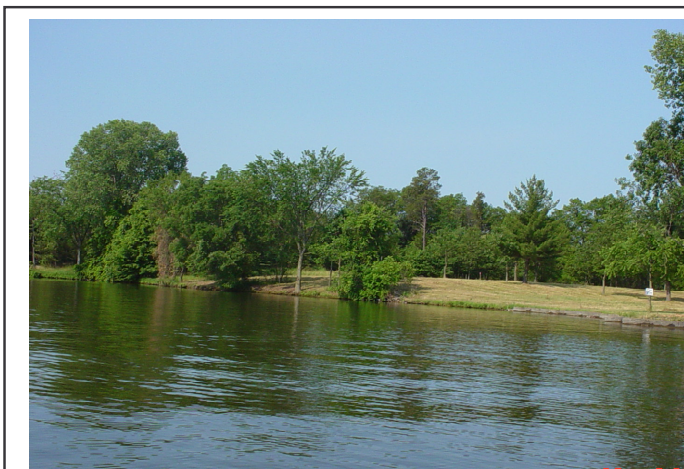
Example of Inadequate Buffer

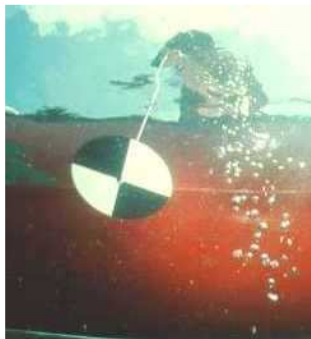
Water clarity readings are usually taken by using a Secchi disk (shown at right). **Average summer Secchi disk clarity in Lower Camelot Lake in 2004-2006 was 5.54' feet.** This places it in the “fair” category for water clarity. **Average summer Secchi disk clarity in Upper Camelot Lake in 2004-2006 was 6.19'.** This puts it in the “good” category for water clarity.

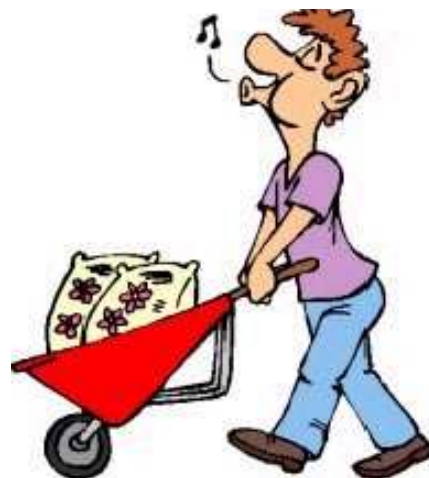
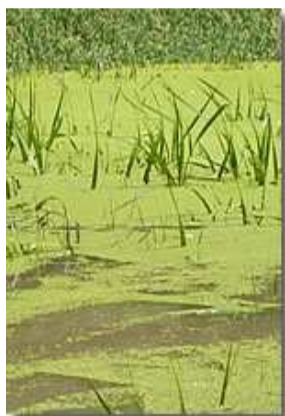
Increased phosphorus levels in a lake will feed algal blooms and also may cause excess plant growth. **The 2004-2006 summer average phosphorus concentration in Lower Camelot Lake was 23.17 micrograms/liter. The average for Upper Camelot Lake was 16.92 micrograms/liter.** Both of these levels score “good” in the total phosphorus category and are below the average 30 micrograms/liter for impoundments in Wisconsin.

The third measure used in trophic state classification is the amount of chlorophyll-a contained in the lake. The amount of chlorophyll-a found in a lake is an indication about the amount of algae in the lake. **The 2004-2006 summer average chlorophyll-a concentration in Lower Camelot Lake was 15.53 micrograms/liter.** This level of chlorophyll-a gives Lower Camelot Lake a “fair/poor” ranking for chlorophyll-a, suggesting frequent algal blooms are probably occurring. Average for the 1990s was 19 micrograms/liter—slightly lower and squarely in the “poor” category.

The summer average chlorophyll-a concentration in Upper Camelot Lake was 11.9 micrograms/liter. This places Upper Camelot Lake in the “fair” category. It probably has fewer algal blooms than Lower Camelot Lake, but chlorophyll-a readings are high enough that some blooms would be expected. Average in the 1990s was 8.5 micrograms/liter, in the “good” category.
